# Manhole Inspection Summary

Manhole # S21K\_\_030MH

**Location** Address: **213 MONROE ST**

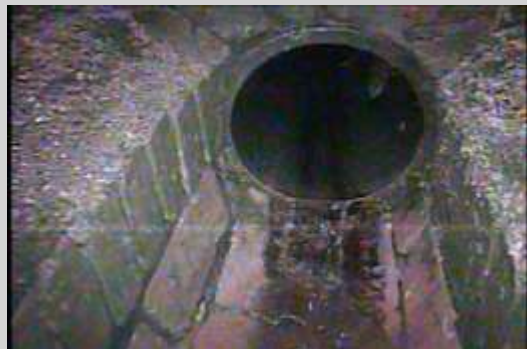
6 O'Clock Inflow

8 in. Circular Gravity Sewer

Pipe In @ 6 O'Clock

Pipe Height: **7.2** (in.) Rod and Bar (Angled)

Pipe Material: **Clay** ☐ Pipe Lined

Infiltration: **None** Pipe Seal Cond: **Sound**
